Marine Survey and Assessment for Potential Mitigation Sites  
Miami Harbor General Re-evaluation Report  
Miami Harbor, Miami-Dade County, Florida

**MARINE SURVEY AND ASSESSMENT  
FOR POTENTIAL MITIGATION SITES  
MIAMI HARBOR GENERAL RE-EVALUATION REPORT  
MIAMI HARBOR  
MIAMI-DADE COUNTY, FLORIDA**

**October 2002**

**Prepared by:  
Dial Cordy and Associates Inc.  
490 Osceola Avenue  
Jacksonville Beach, FL 32250**

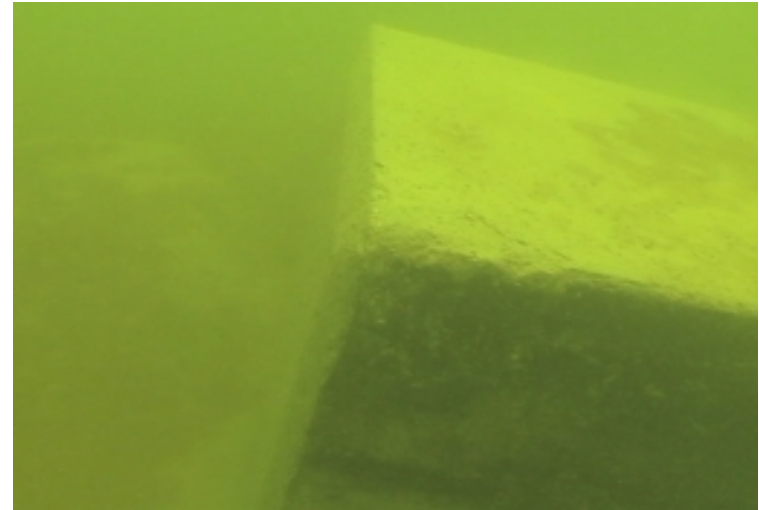
Photograph 2. Artificial reef material placed in previously dredged borrow areas . Reef material showed no living growth and was covered in a fine silt.

Previously placed artificial reef material was also encountered in the deeper (>20 feet, NAVD 88) sections of the survey area (Figure 7) (Photograph 2, Appendix A). This area is close to the area identified as Area III-A by Coastal Technology (1989). This area appears to be significantly deeper than previously identified in the earlier report and now contains an artificial reef. This artificial reef material consisted of large cement pilings stacked on the bottom. No apparent growth was observed on artificial reef material.

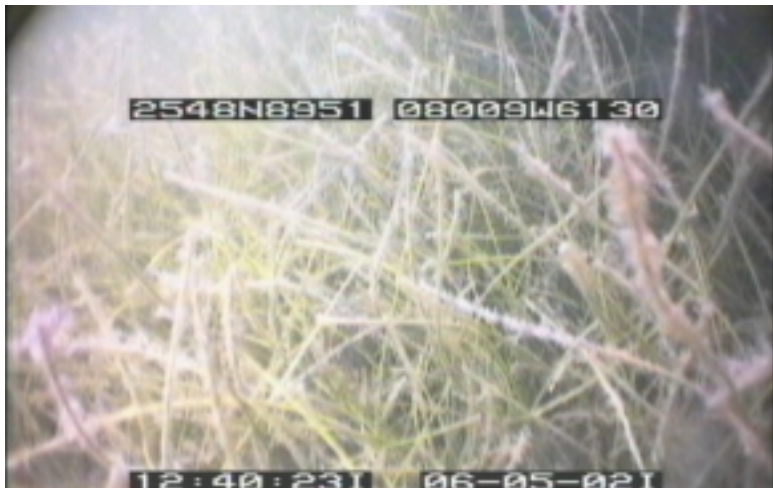
Photograph 3. Towed video captured image showing dense *Syringodium filiforme* along edge of previous borrow area.

Seagrass distribution is illustrated in Figure 5. The area surrounding the borrow areas was dominated by *S. filiforme* along the northern edge of the survey area (Photograph 3, Appendix A). Small patches of *H. decipiens* and *H. wrightii* occur where the bottom begins to slope toward previously dredged areas along the northwestern edge of the survey area (Figure 5). Along these edges of the previously dredged areas, *S. filiforme* and *T. testudinum* become sparse and *H. decipiens* occurs. Along the southern portions of the survey area, mixed seagrasses were most prevalent. Mixed assemblages of *S. filiforme*, *H. wrightii*, *T. testudinum*, and along some of the interior deeper edges, *H. decipiens* were most common.

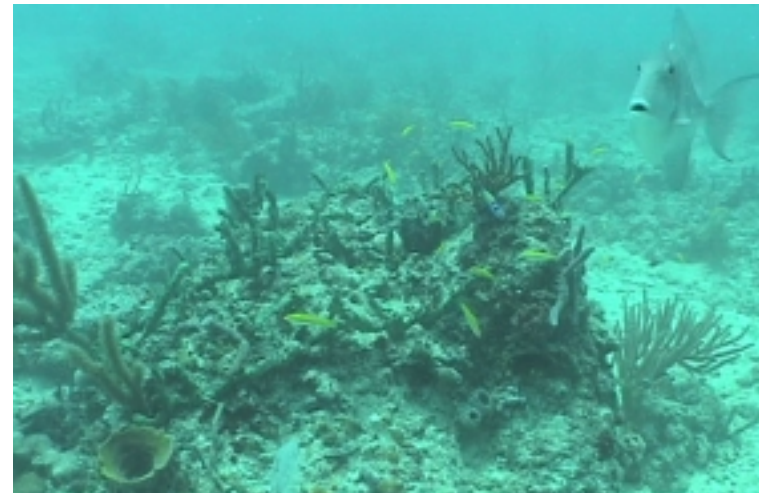
Photograph 4. Hardbottom habitat present within potential offshore mitigation areas.

Two potential offshore artificial reef areas were surveyed. Hardbottom habitats were delineated using data collected from the integrated towed video survey and locations of suitable potential reef sites located. Localized areas of hardbottom habitats were located within each of the offshore areas surveyed and are shown on Figure 7 and Photograph 4 (Appendix A).
